CARDIVNSWC-TR-61-98-29

Survivability, Structures, and Materials Directorate
Technical Report

Crevice Corrosion Performance of Candidate Naval Ship Seawater Valve Materials in Quiescent and Flowing Natural Seawater

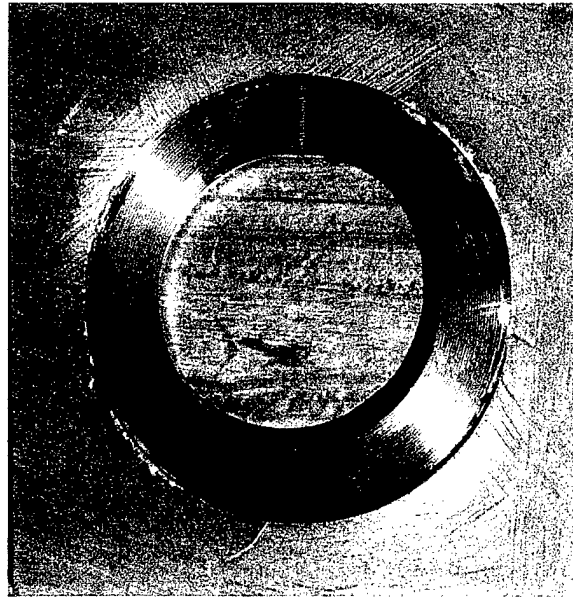
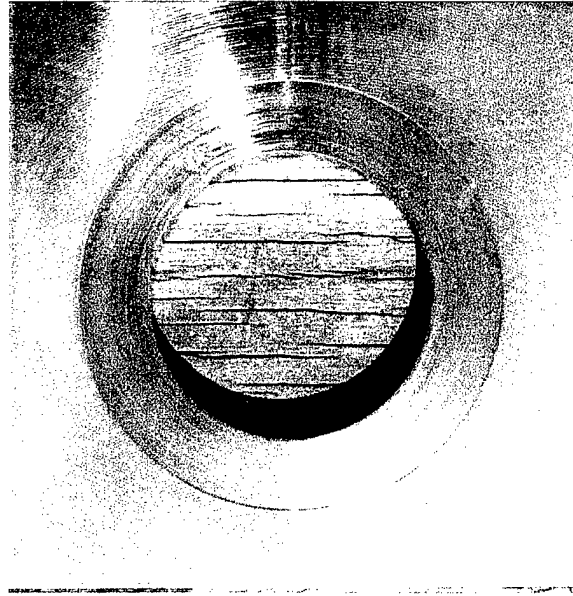
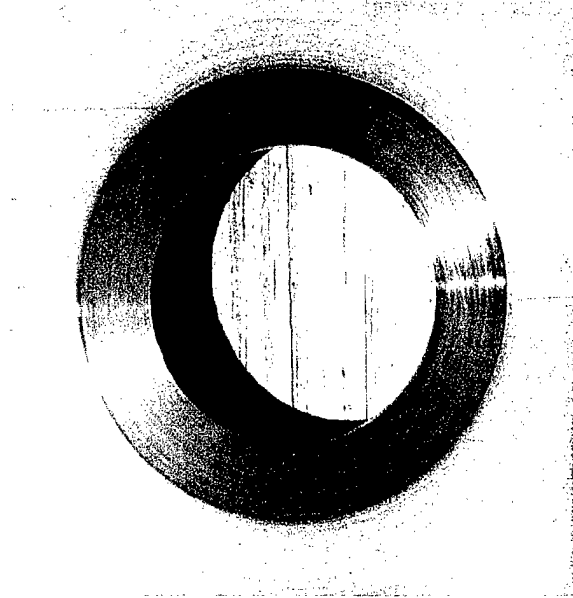
Figure 20. CN7M, SCF23, and 654 SMO After 180 Days in 6 ft/sec (1.8 m/sec)
Flowing Natural Seawater

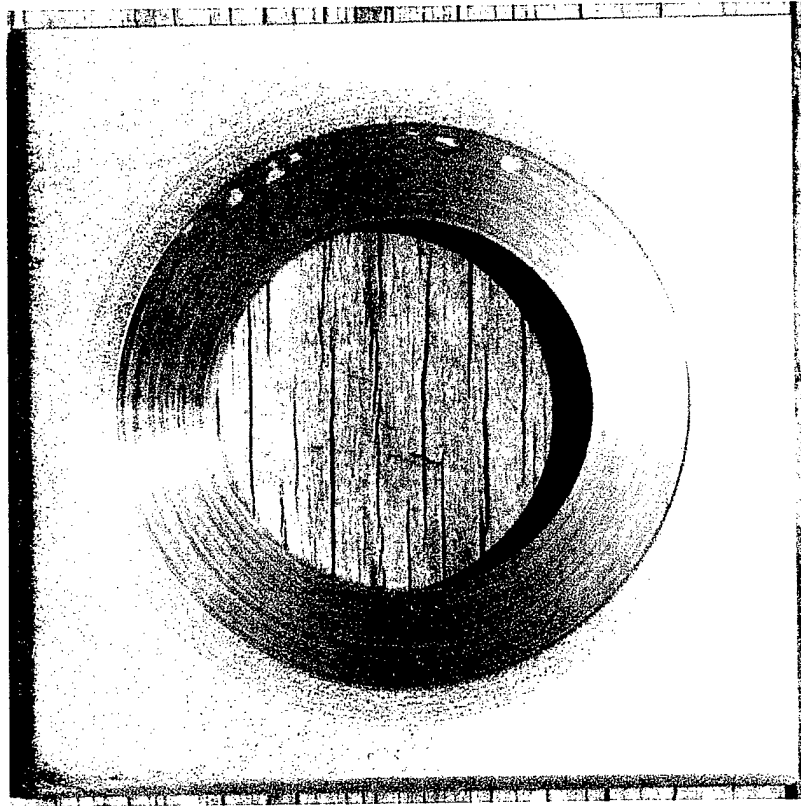
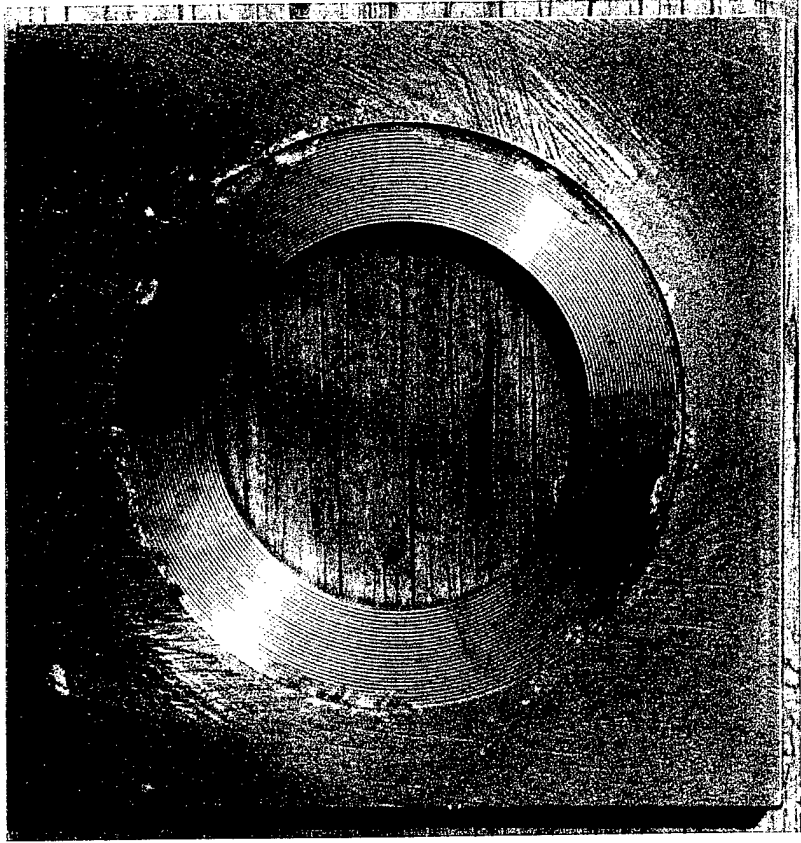
Figure 21. Wrought 254SMO and Cast CK3MCuN After 180 Days in 6 ft/sec (1.8 m/sec)
Flowing Natural Seawater

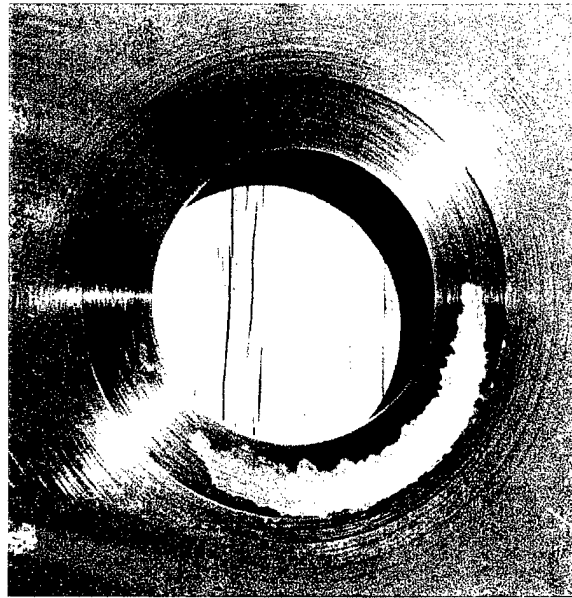
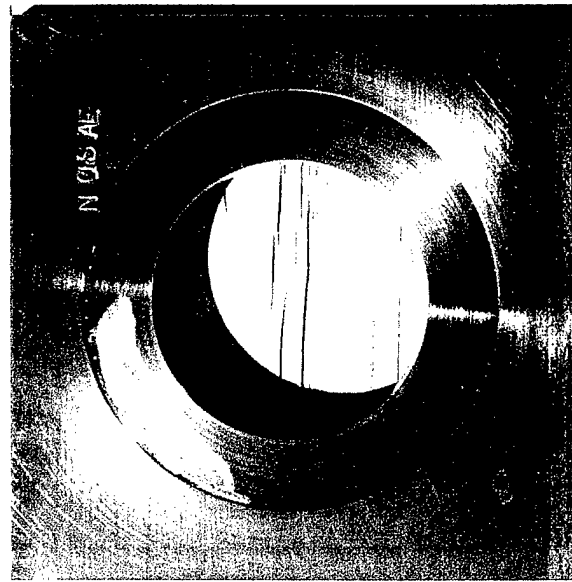
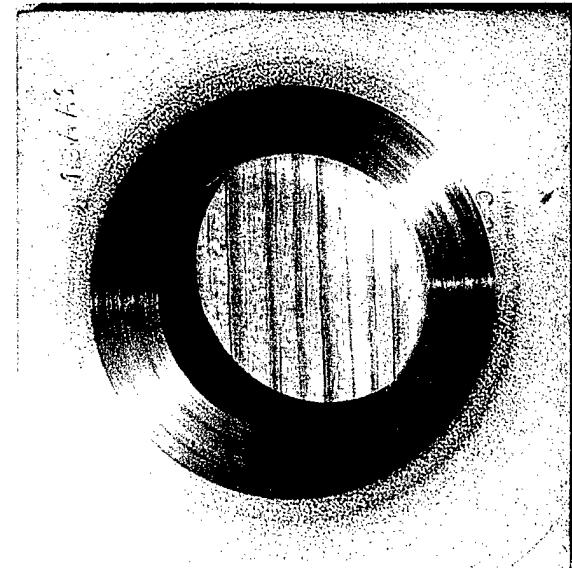
Figure 22. Wrought Alloys 718, 925, and C2000 After 180 Days in 6 ft/sec (1.8 m/sec) Flowing Natural Seawater

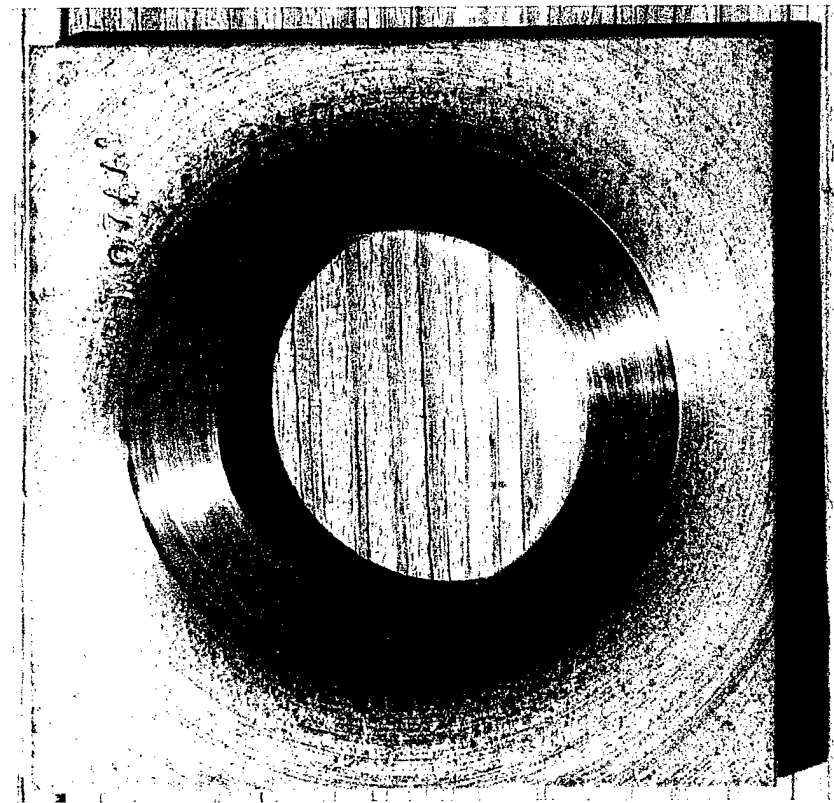
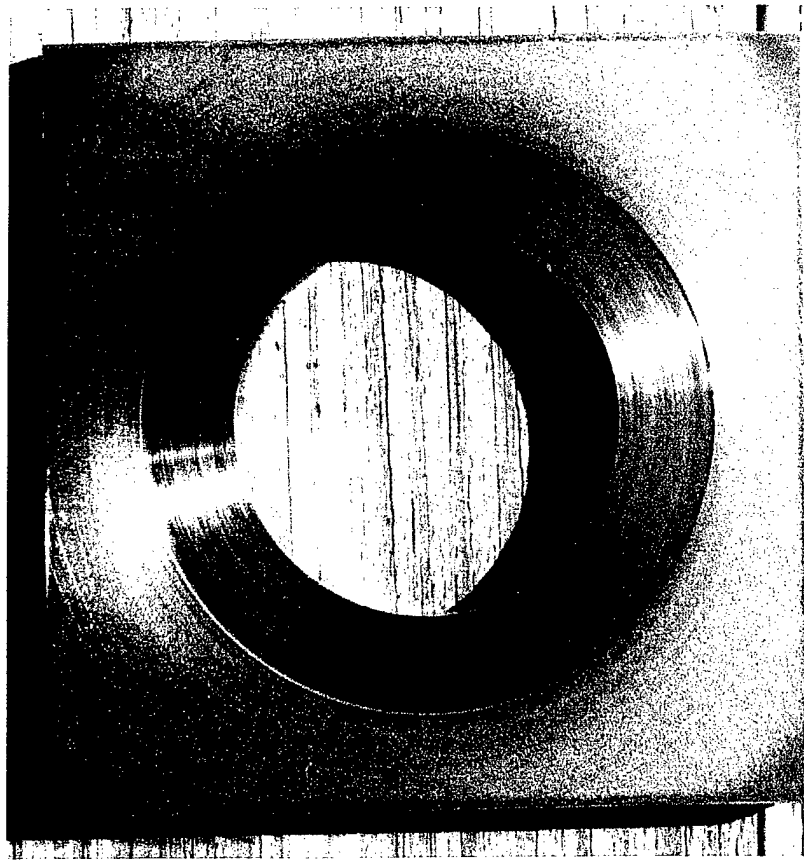
Figure 23. Cobalt Alloys After 180 Days in 6 ft/sec (1.8 m/sec) Flowing Natural Seawater

The two cobalt alloys, Haynes 25 and Ultimet, were fully resistant to crevice corrosion in flowing conditions (Table 9 and Figure 23). There was no indication of corrosion present on any of these specimens.
